Replacing a Faulty Hall Sensor* Cable (Cause of No-Start)

1987 740 TURBO, LH-JETRONIC 2.2, EZ 117K IGNITION SYSTEM

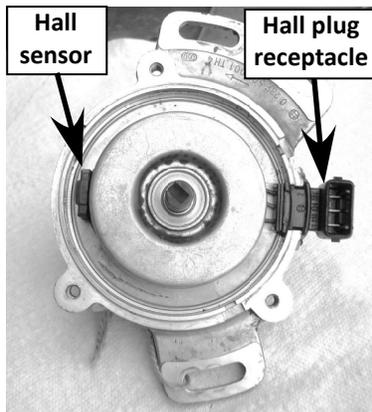
Figure 1. The distributor base-plate with Hall sensor and Hall plug receptacle.

Result: The short circuit will have killed the Hall sensor (Figure 1), necessitating a replacement Hall sensor *and* a fix of the short circuit.

Postscript. It is unusual to have two faults occur simultaneously, but my most current no-start occurred from a Hall plug short circuit *and* a faulty Hall sensor. Turns out that the short circuit in the Hall plug between the signal wire (blue, 5 VDC) and power wire (red, 12 VDC) fried the sensitive electronic circuits inside the Hall sensor. It has been 15 years and 58,400 miles on that Bosch Hall sensor, which would have lasted longer had there been no short circuit. Before this current no-start, I noticed, over a period of many months, that the Hall plug was soaked in oil. I foolishly ignored the situation. If you find gobs of oil on your Hall plug, consider pulling the distributor (see "Replacing/Repairing the In-Line Distributor") and replacing the large green O-ring on the distributor baseplate (**Figure 33**). Doing so may well save your Hall sensor and prevent you from becoming stranded on the side of the road.

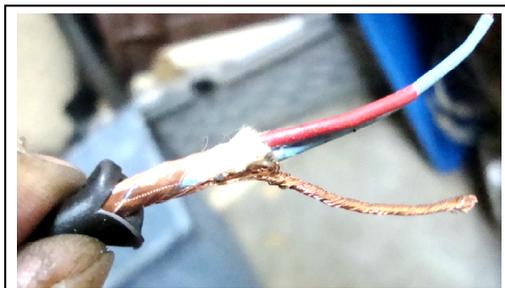
Figure 2. The ground wire of the Hall cable is the twisted end of the cylindrical copper sheath. Note red and blue hot wires.

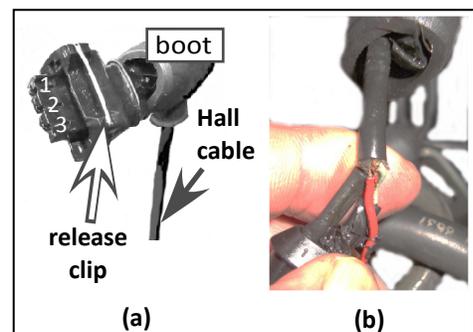
Symptoms: Engine hiccupped, then intermittently died over a period of months. Sometimes it restarted right away, other times not. Eventually engine stayed dead (but cranked). Ran tests. Got 0.25 VDC at ignition "On," instead of 12 VDC, when testing #3 red wire of Hall plug. Found bare hot wires in Hall plug, which caused a short circuit. What caused worn insulation? Engine heat and *lots of oil* leaking past large O-ring of distributor into and around Hall plug.

again and buying the wrong part (fortunately, used and cheap), I traced one aspect of the no-start. It was a short circuit between exposed wires at the Hall plug (Figure 3a), located at the bottom of the distributor. *There are three wires in the the shielded Hall cable that end at the Hall plug: #3 (red, 12 VDC at Ignition "On,"), #2 (blue, 5 VDC at Ignition "On,") and #1 (black, ground).* The two hot wires have rubber insulation, and the ground wire is the twisted end of the copper sheath that forms the shielding for the whole (Figure 2). The ground wire is usually bare at the terminus of the shielded cable and insulated going into the plug. The problem was the insulation of the two hot wires had worn away. The exposed wires created a short circuit (Figure 3b). [A short circuit is a short unintended path for current to go from a hot wire to another wire or ground, rather than traveling its designed path through the device in question—in this case, the Hall sensor.]

Figure 3. (a) The Hall plug showing the connector terminals, rubber boot, cable, and release clip. Terminal 3 faces passenger side when plug is connected. (b) Exposed strands of the Hall plug wires, where the insulation had worn away from oil, heat, and handling, led to a short circuit.

One Solution for short circuit: Replace the Hall cable, which runs from the distributor to the Ignition Control Unit (ICU). *THIS DIFFICULT TASK INVOLVES WORKING IN CRAMPED SPACES AND CONTORTING YOUR BODY UNDERNEATH THE DASH TO ISOLATE AND FREE THE HALL CABLE. NOT EASY!*

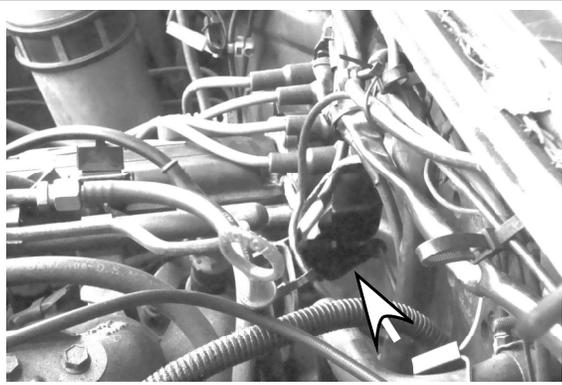
Figure 4. The arrow shows the location of the Hall plug, at bottom of distributor and close to firewall. Unplug it from receptacle.

Before beginning, disconnect the battery ground cable. If you haven't removed the Hall plug, do so now. It is on the bottom of the distributor against the firewall (**Figure 4**). Feel for the spring clip at the bottom of the Hall plug; press it up while pulling the plug backward to release. Once the Hall plug is released, cut the zip ties holding the cable per **Figure 5**.

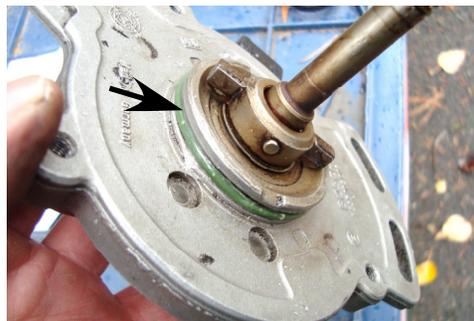
Figure 33. Photo showing distributor's green large O-ring (arrow), which should be replaced if excessive oil is found on the Hall plug. Doing so may save your Hall sensor.
