Replacing a Faulty Hall Sensor* Cable (Cause of No-Start)

1987 740 TURBO, LH-JETRONIC 2.2, EZ 117K IGNITION SYSTEM

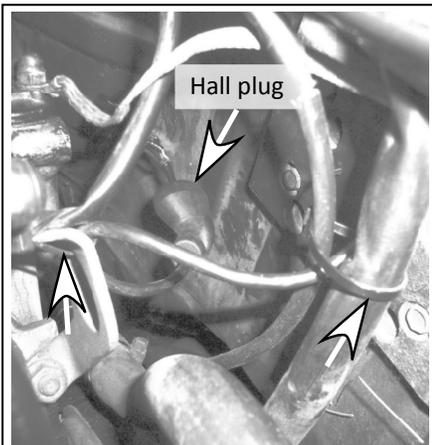
Figure 5. Cut the zip ties (uncaptioned arrows) holding the Hall cable. Note these points for installation of the replacement Hall cable.

Before beginning, disconnect the battery ground cable. If you haven't removed the Hall plug, do so now. It is on the bottom of the distributor against the firewall (**Figure 4**). Feel for the spring clip at the bottom of the Hall plug; press it up while pulling the plug backward to release. Once the Hall plug is released, cut the zip ties holding the cable per **Figure 5**.

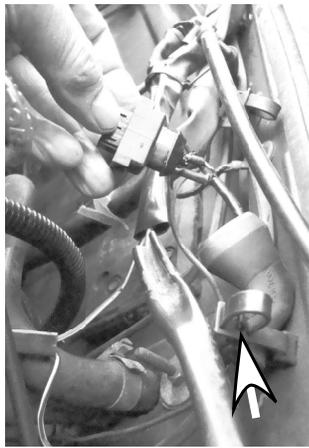
Figure 6. Push the Hall cable alongside the firewall. The arrow shows the release tab for the reversible zip tie.

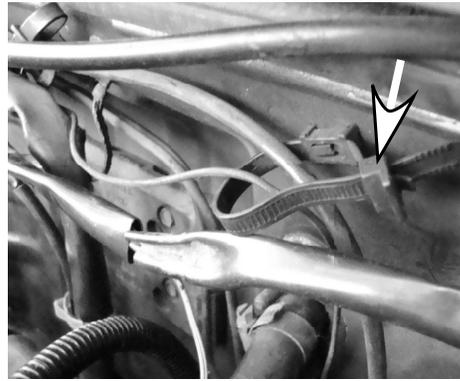
Figure 7. Release the reversible zip tie by pulling its end free and then pressing down on the short tab (see *Figure 6*) while pushing the end through the lock block (arrow).

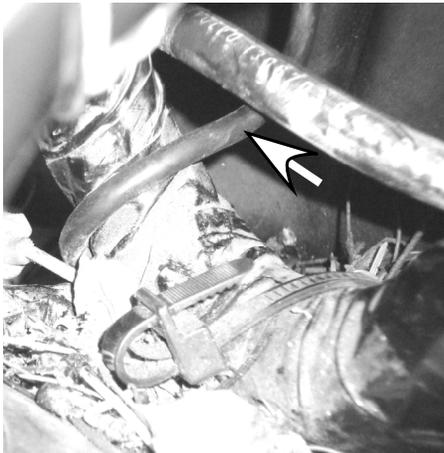
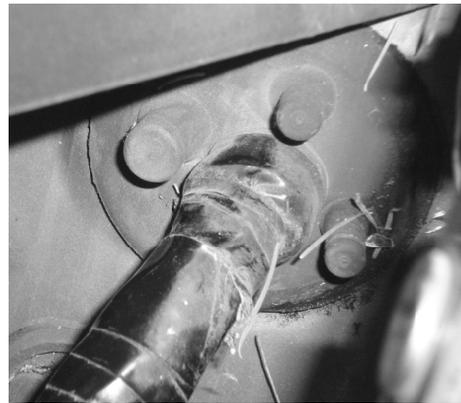
Figure 8. These photos show the taped wire bundle behind the left (driver's side) suspension tower. (a) The arrow shows the Hall cable wrapping around the wire bundle before being incorporated by it to go through the firewall (b).

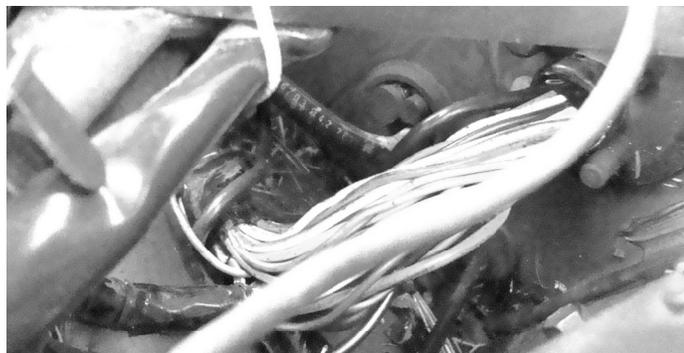
Figure 9. Cut the zip tie shown in *Figure 8a* and use a one-sided razor blade to lightly score the electrical tape along the length of the wire bundle. Then peel the electrical tape off to expose the wires as shown. You should now be able to isolate the Hall cable going into the hole of the firewall.

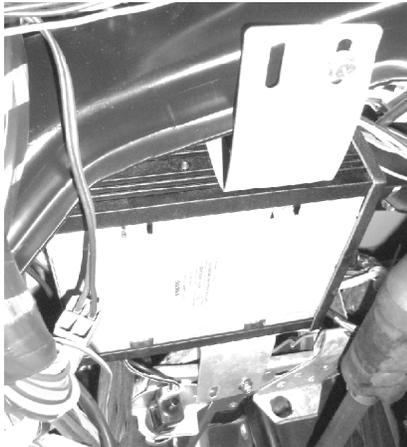
Figure 10. Remove the two 8 mm screws holding the amplifier and lower it to floor. Mark the background holes for easy replacement.

If you haven't done so already, remove the trim from underneath the driver's side dash. On some models, all you have to do is rotate plastic fasteners 90° and remove a Phillips screw; on other models, I recall removing 10 mm screws. Then, for more access, lower the radio amplifier (**Figure 10**) out of the way.

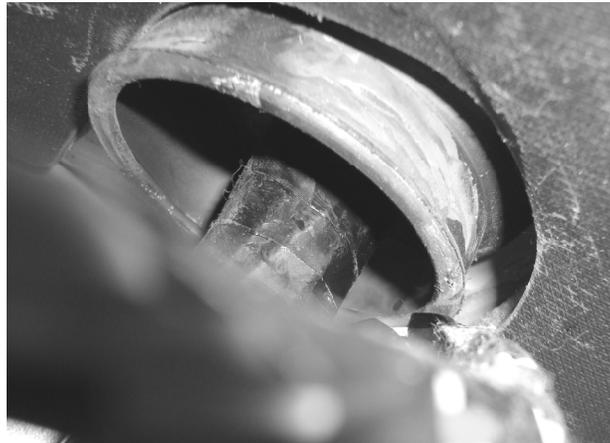
Figure 11. Inside view of the wire bundle of *Figure 8b* coming through the firewall. Getting a good view and feel (for cutting away the electrical tape) entails pushing a lot of other wire bundles out of the way. A good headlamp is handy for illumination under the dash.

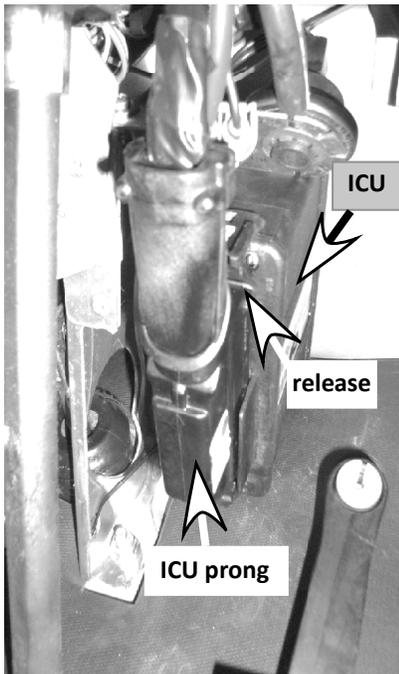
Figure 12. Locate the boxy Ignition Control Unit (ICU, arrow) above the gas pedal. The feed wires are contained in the ICU prong (arrow). To disconnect the prong, start by pressing on the brass release tab (arrow). This frees the tail end of the prong. To release the front end you need to lift the prong wire bundle off the black hook (right arrow, *Figure 13*) and cut the zip tie (left arrow, *Figure 13*). Then, pivot the whole prong forward ~90° to an almost vertical position to be able to unhook the forward latch. Next, push the vertical prong rearward to release.

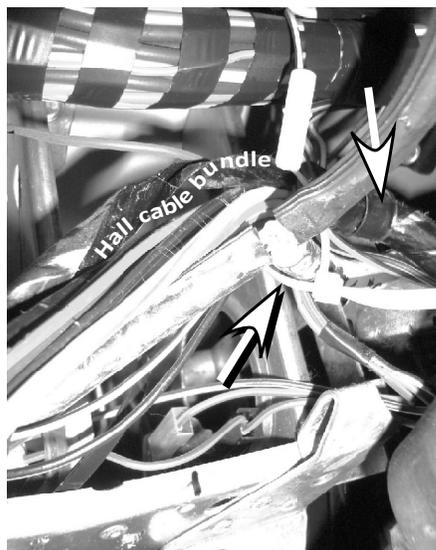
Figure 13. The Hall cable bundle is labeled in the photo. It is hung to the underframe by the zip tie and the black hook (both arrowed).

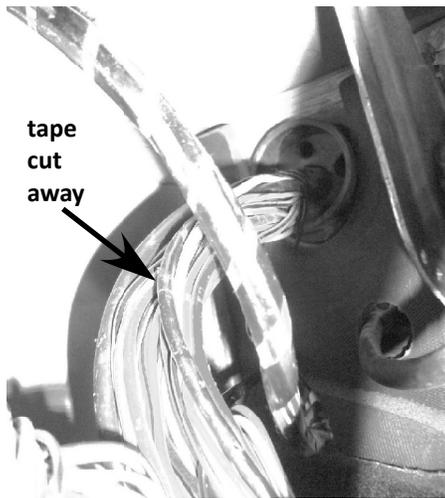
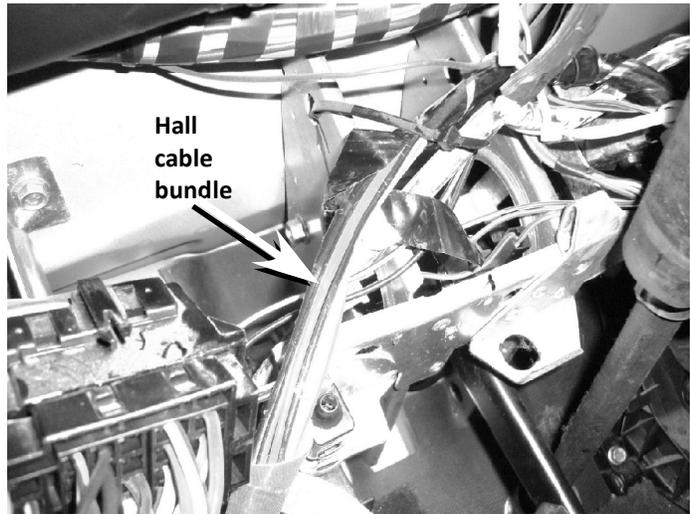
Figure 14. Under the dash, score and then peel away the electrical tape from the wire bundles, near the firewall (a) and closer to the ICU prong (b) to expose the Hall cable.

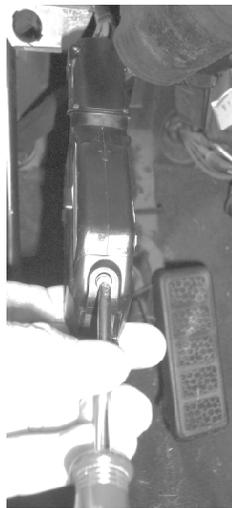
Figure 15. Remove the small Phillips screw from the top (forward end) of the ICU prong. Use #1 Phillips screwdriver, as the screw is tight and its slots are easily rounded (same caution for *Figure 16*).

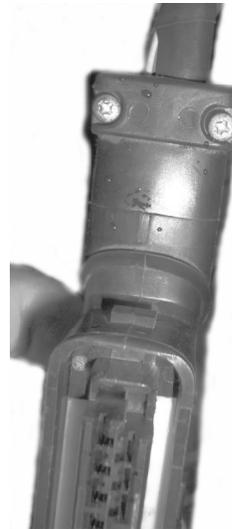
Figure 16. Remove the two Phillips screws at the tail of the ICU prong. Pull the back cover off to expose the wires at the tail. Score and cut away any electrical tape holding the tail wires together. Identify the Hall cable.

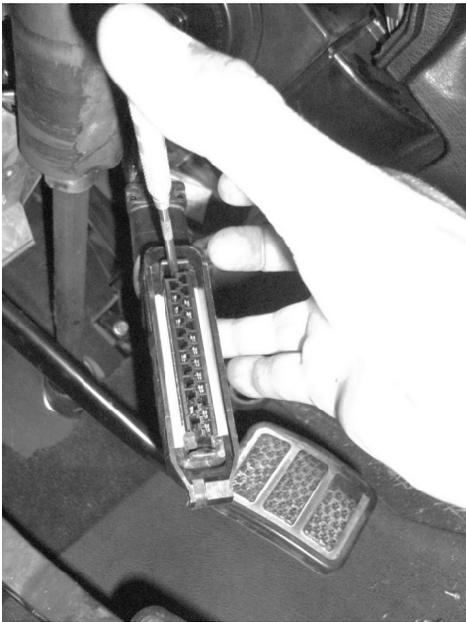
Figure 17. Insert a pick into the hole in the tail end side of connector socket and exert pressure toward tail on end of pick handle to pivot the connector socket free from the ICU prong housing.

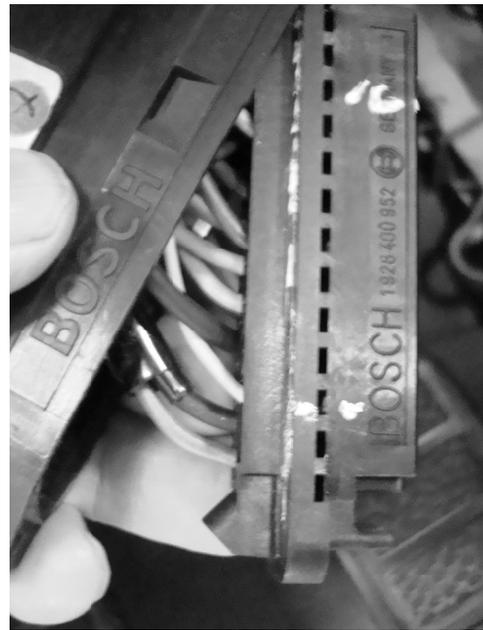
Figure 18. Pull the wire connector socket out of the ICU prong housing as shown to expose the wiring.

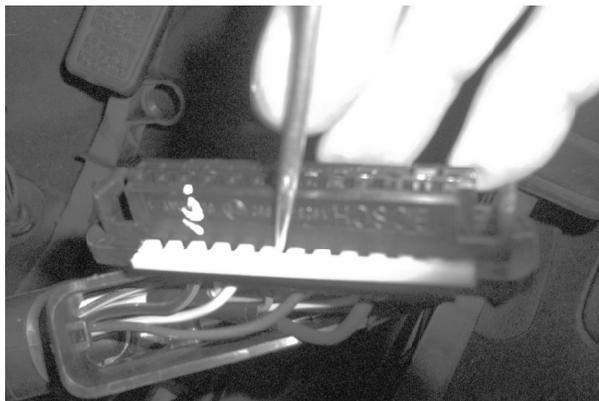
Figure 19. Use a pick to pry out the two plastic inserts on the sides of the socket. These inserts help hold the electrical connectors in place.

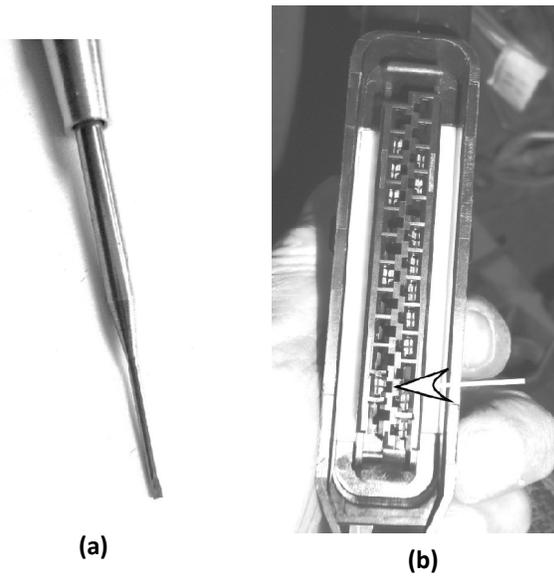
Figure 20. (a) I used the smallest head (0.94 mm, slightly larger than 1/32") of my jeweler's screwdriver set to remove the Hall cable wires from the prong socket. Another suggestion was a finely ground pick. (b) To free a connector, insert the miniature blade into the channel shown by the arrow (which is back side of connector) while gently pulling on the wire from the back. Make sure that the plastic inserts of *Figure 19* have been removed. (In this photo, the inserts are still present.)

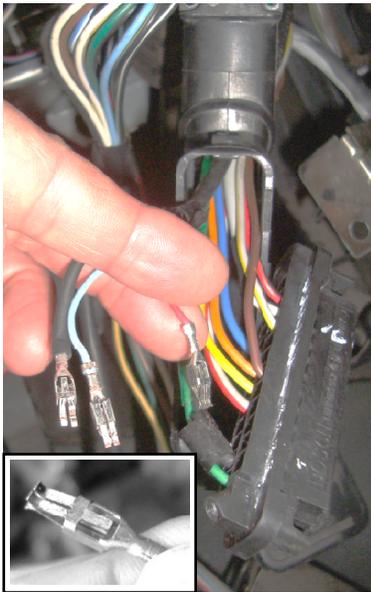
Figure 21. The three wires of the Hall cable have been released from the ICU prong connector socket. They are the red wire from the #4 terminal of prong, the blue wire from #24, and the black wire from #10. (See the EZ 117K wiring diagram for reference.) Inset: Close-up of terminal connector. Fragile! Note locking tab on back.

After you've removed the three Hall wires from the ICU prong connector socket as shown in **Figure 21**, cut the terminal connector ends off and pull the whole cable back through the firewall into the engine compartment. You may have to work the cable a bit from under the dash and through the wire bundle at the firewall. (**Figure 21 inset** shows a close-up sample of the terminal connector. The Hall plug and ICU prong terminal connectors are identical.)

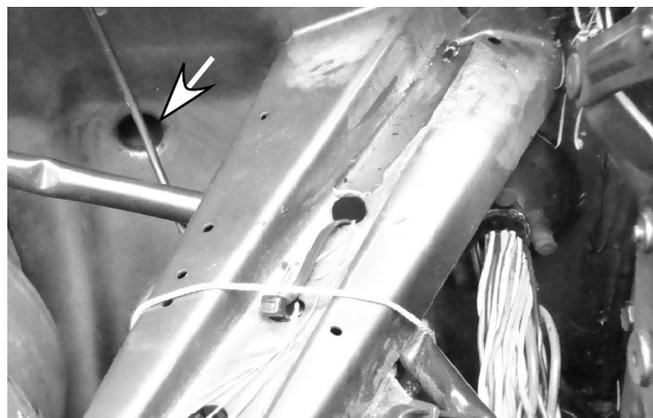
Figure 23. Pry out the rubber plug, medial to the exposed wire bundle, to open up a new hole (arrow) in the firewall.

Now you're ready to install the replacement Hall cable. Don't fight going through the old hole in the firewall with the original wire bundle. Volvo has conveniently provided additional holes (**Figure 23**).

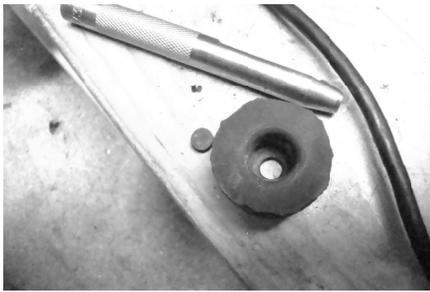
Figure 24. Use a 5/16" hole punch to cut a hole in the rubber plug. Insert plug over Hall cable, being careful not to damage the terminal connector ends. *The narrow diameter end of the rubber plug faces the ICU prong terminal ends.*

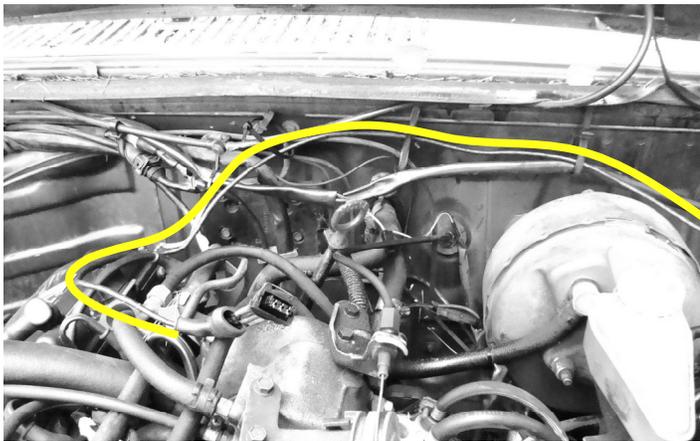
Figure 25. Wrap the ICU connector end of the Hall cable with masking or electrical tape to protect the terminal ends, which can be easily damaged. Run the Hall cable (visible next to yellow line in photo) through the reversible zip ties you opened during removal and zip tie the cable loosely to zip points noted earlier (*Figure 5*).

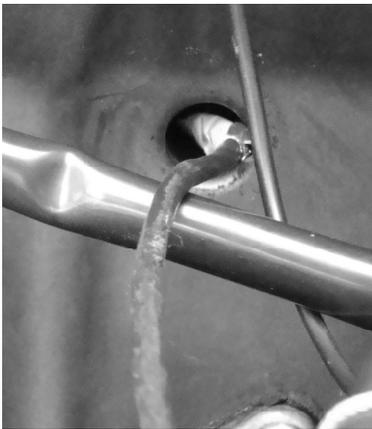
Figure 26. Push the taped ICU connector ends of the replacement Hall cable through the new hole in the firewall. Go under the dash and pull the cable in.

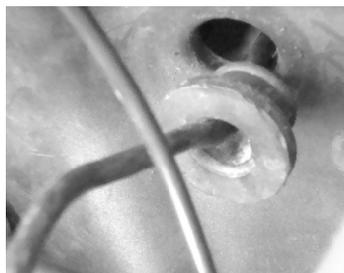
Figure 27. Take up the Hall cable slack within the engine compartment by pushing the cable through the hole in the firewall. Set the rubber plug into the firewall.

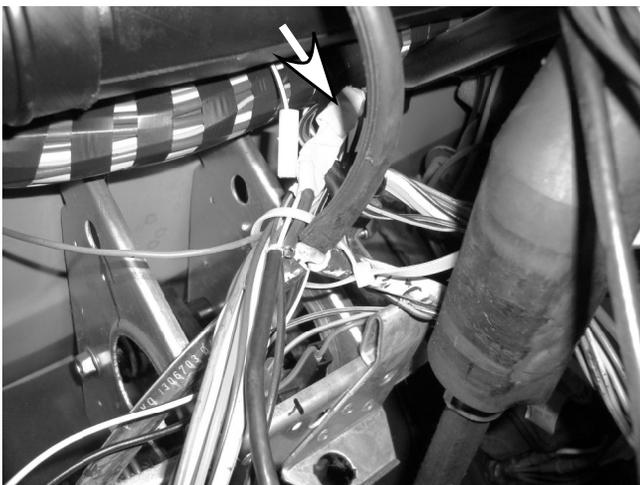
Figure 28. Under the dash, take up any slack on the Hall cable and run it alongside the ICU wire bundle. The arrow shows the taped end of the Hall cable. Fit the cable through any zip ties and over the black plastic hook (*Figure 13*) for the ICU wire bundle. Then run the cable through the tail housing of the ICU prong.

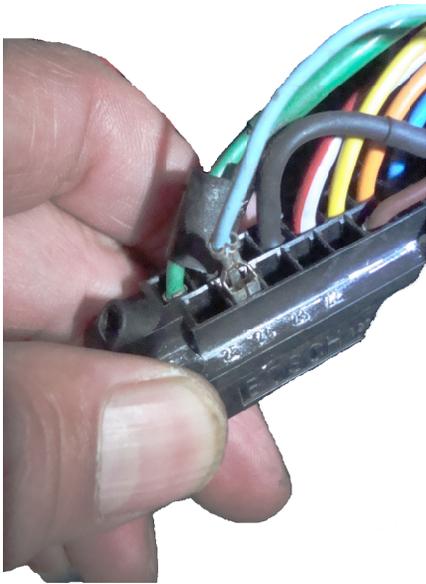
Figure 29. Remove the tape from the connector ends. Insert the connectors into the back of the ICU prong socket with the locking tab of each connector facing medial. Here, the blue (#2 of Hall plug) connector terminal is being inserted into the #24 position of the ICU prong socket. Insert the red (#3) connector into the #4 position of the ICU socket and the black (#1) connector into the #10 position of the ICU socket. (Double-check the correct position for your ignition system.)

After inserting the terminal connectors of the Hall cable into the back of the ICU prong socket (**Figure 29**), push the white plastic strips of **Figure 19** into the holes on the side of the socket. These strips hold the terminal connectors in place. Use good electrical tape to wrap the wires going into the tail of the prong (**Figure 30**). (I like 3M Super 88 electrical tape.) Next, push the connector socket back into the prong shell, snapping it in place so that socket face is flush with the prong face. Put the tail tab on the prong and secure with the two Phillips screws (**Figure 16**). Then, secure the head of the prong with one Phillips screw (**Figure 15**). Under the dash, wrap wires with electrical tape all the way back to the firewall—no need to wrap every square inch; feel free to leave gaps of unwrapped wires (**Figure 31**).

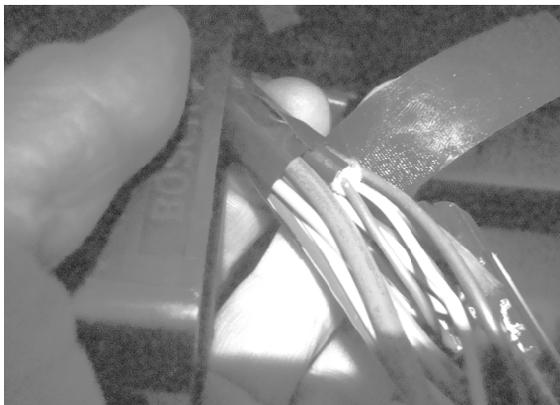
Figure 30. Wrap electrical tape around the ICU prong wires at the tail end of the prong. Then push and snap the connector block back into the prong housing, and secure with screws per *Figures 15 and 16*.

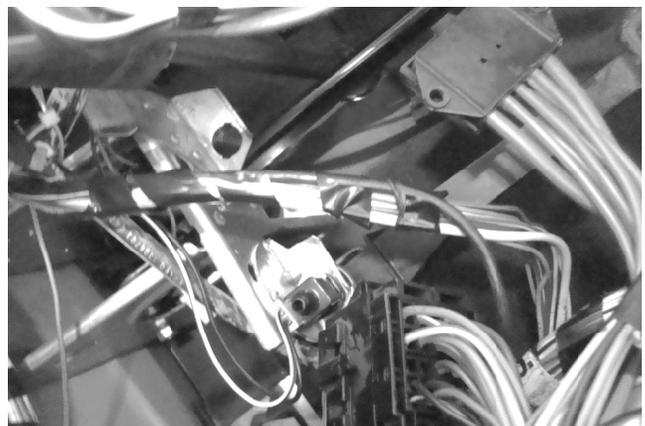
Figure 31. Under the dash, you can leave gaps when you wrap the wire bundles with electrical tape.

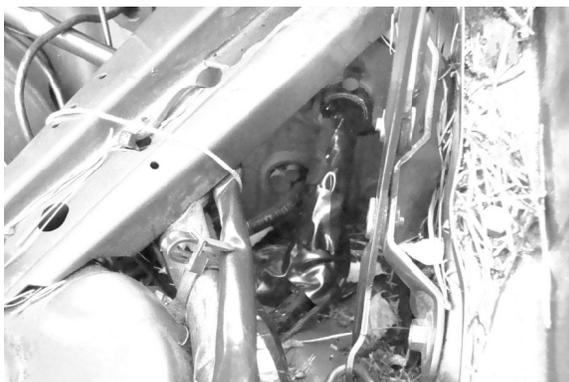
Figure 32. In the engine compartment, rewrap the wire bundle going through the firewall. This is the wire bundle that previously held the old Hall cable.

In the engine compartment, because of exposure to oil and heat, completely rewrap the wires going into the firewall (**Figure 32**). Back under the dash, carefully insert the front end of the prong into the ICU, making sure the appropriate pins and connectors line up. Then pivot about the front end to insert the rear of the prong into the ICU and snap in place, so the whole assembly looks like **Figure 12**. Hang the Hall cable bundle under the dash onto the black plastic hook (**Figure 13**). Zip tie, where needed, to support the wire bundle.
